# FIGHTING DR. MOON DENIALS BASED ON RUST ANALYSIS

**Metal Corrosion: A Qualitative Analysis**  
N.Wells; C.A. Martinez; M, Bass; and R.E. Moon  
GHD, Building Science Dept.,  
4019 East Fowler Ave., Tampa, FL 33617.  
Published Online Nov 9, 2015

Here we provide a critique of *Metal Corrosion: A Qualitative Analysis* show where it goes wrong.

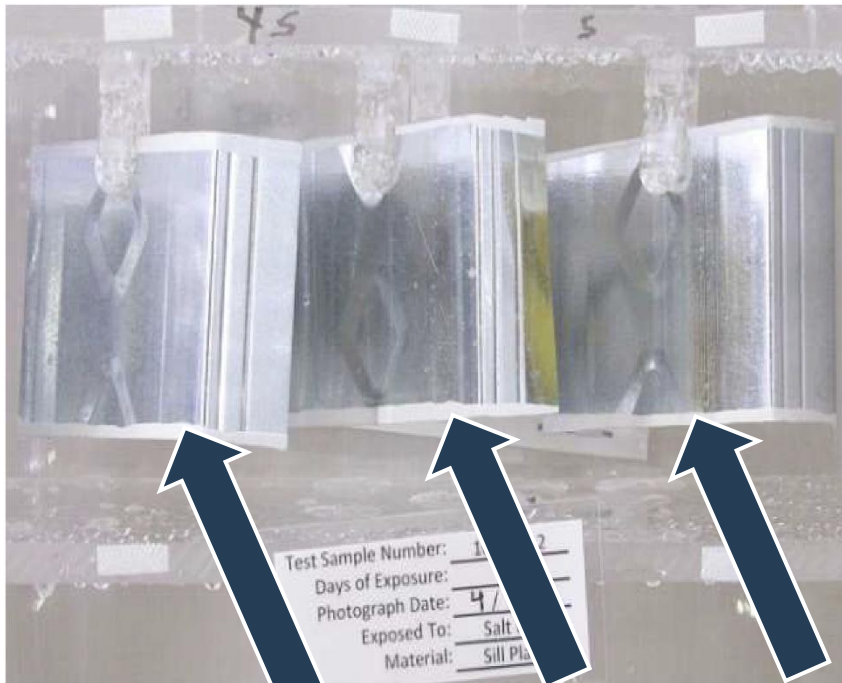
Photo 5: Sill plate in salt water Day 0

Wells et al., 2015 sealed cut ends for 2<sup>nd</sup> Sample Set.

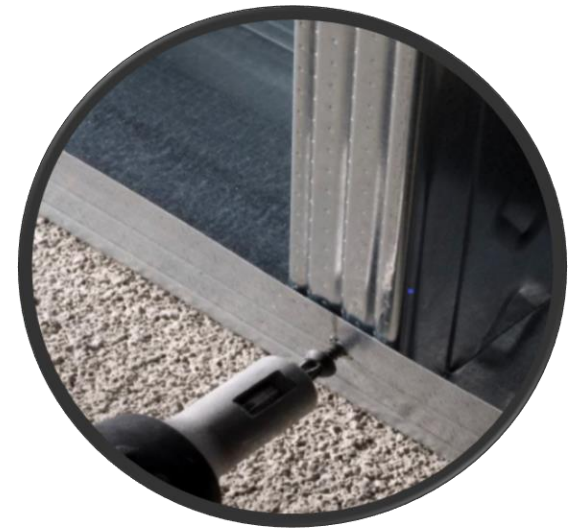
Metal stud sill plate

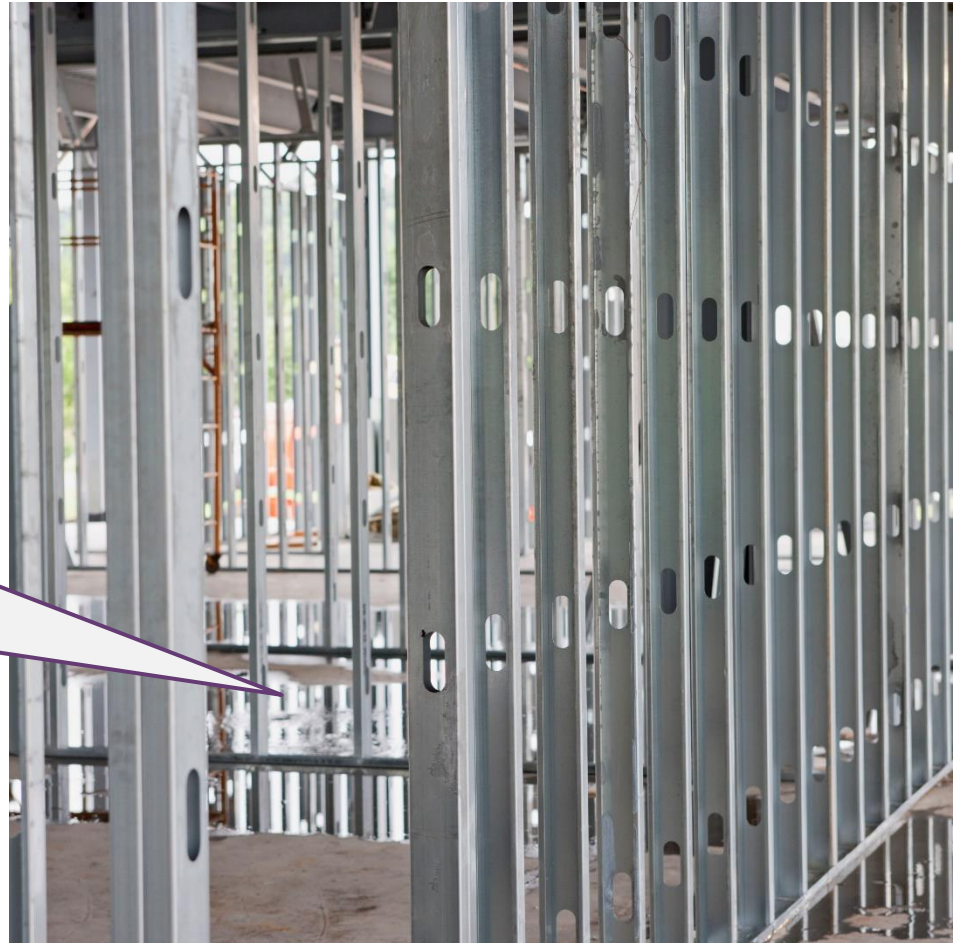
## Often Pre-Existing Rust from Time of Construction

Often there is pre-existing rust on metal framing because during construction framing is often installed before roof is dried in or windows installed.

Defense experts find pre-existing rust not related to recent water event and use this as “proof” of long-term damage. Deny claim.
