# FIGHTING DR. MOON DENIALS BASED ON RUST ANALYSIS

**Metal Corrosion: A Qualitative Analysis**  
N.Wells; C.A. Martinez; M, Bass; and R.E. Moon  
GHD, Building Science Dept.,  
4019 East Fowler Ave., Tampa, FL 33617.  
Published Online Nov 9, 2015

# Wells et al., 2015 On The Rate of Rust Corrosion

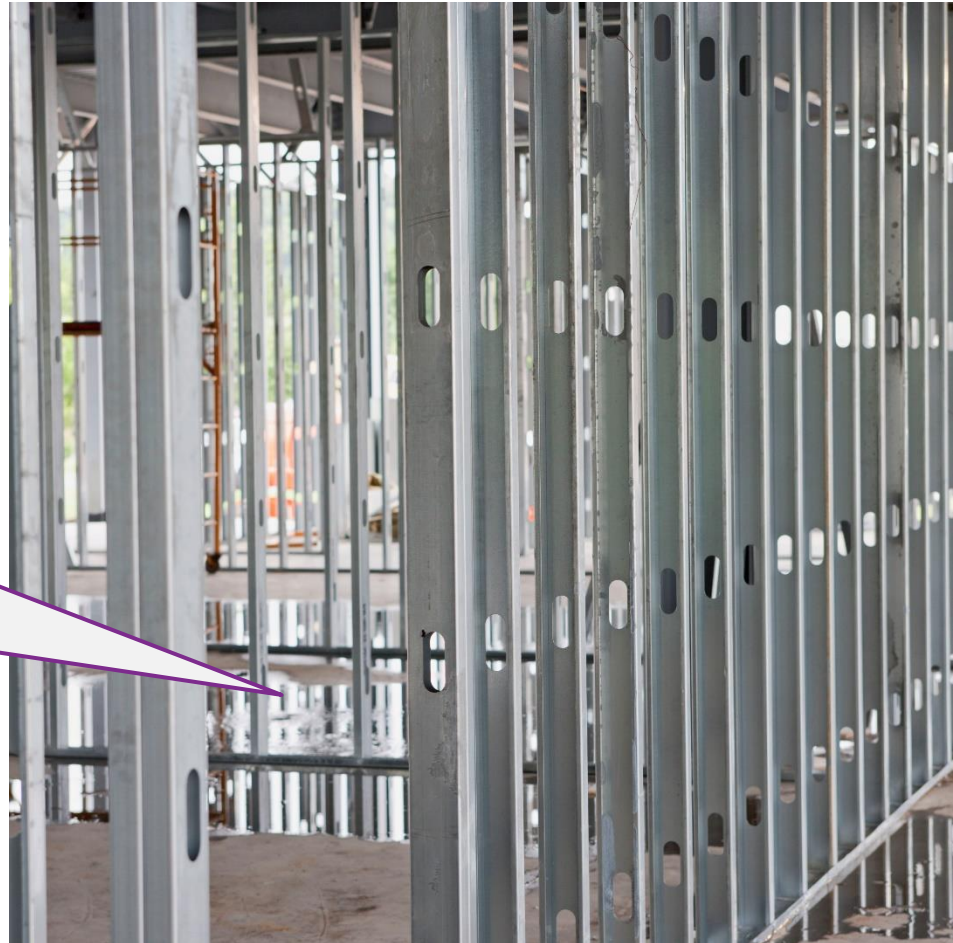
Often there is pre-existing rust on metal framing because during construction framing is often installed before roof is dried in or windows installed.

Defense experts find pre-existing rust not related to recent water event and use this as “proof” of long-term damage. Deny claim.

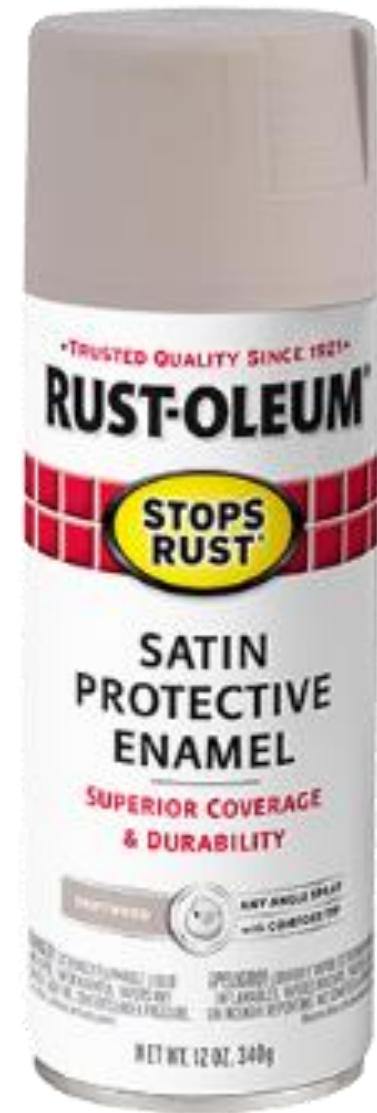
Table 2: Sample Set 2; Color coded changes on the surfaces of the different materials.

- With the cut ends protected with Rust-Oleum they find no rust on the galvanized steel in 43 days. What a surprise result!
- Now they have all the (exemplary!) data they need to deny a claim if no one reads the reference.

Arrow points to no rust at day 43 but with the cut ends painted with Rust-Oleum.
